Manhole Inspection Summary

Manhole # S33S__021MH

Insp Date: **1/29/08 10:48 AM**

Location Address: **ropewalk lane**

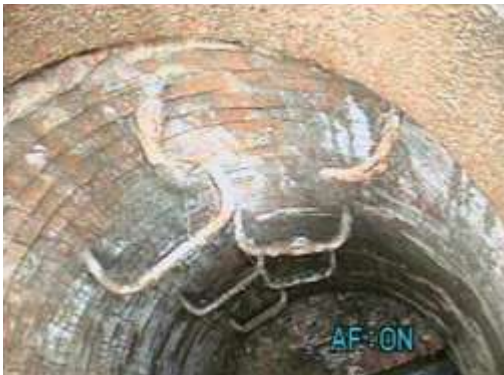
Defect 1

Steps Count: **6** Missing: **1** ☒ **Corroded**

corroded/missing steps

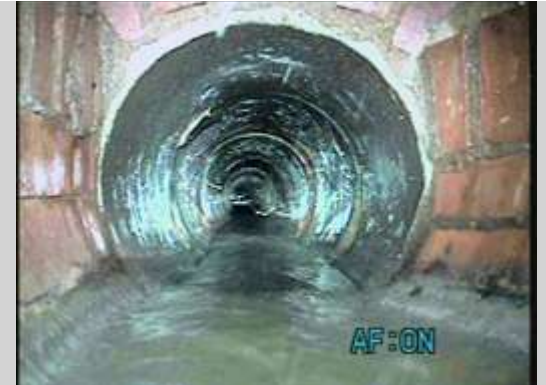
12 O'Clock Outflow

10 in. Circular Gravity Sewer
Pipe Out @ 12 O'Clock

Pipe Material: **Clay** ☐ Pipe Lined

Invert Depth: **9.90** (ft.) Flow Characteristics: **Fast**

Deposits: ☒ None ☐ Mud ☐ Sludge ☐ Debris ☐ Grease

Infiltration: **None** Pipe Seal Cond: **Unknown**

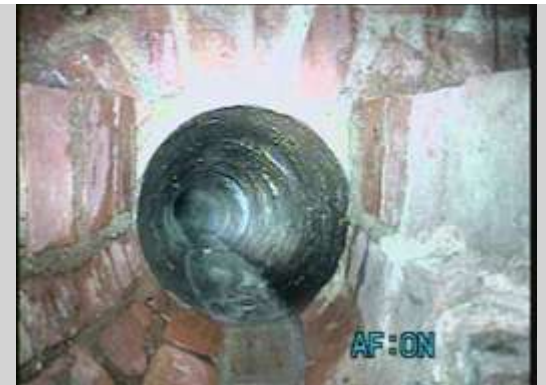
3 O'Clock Inflow

8 in. Circular Gravity Sewer
Pipe In @ 3 O'Clock

Pipe Material: **Clay** ☐ Pipe Lined

Invert Depth: **9.30** (ft.) Flow Characteristics: **None**

Deposits: ☒ None ☐ Mud ☐ Sludge ☐ Debris ☐ Grease

Infiltration: **None** Pipe Seal Cond: **Unknown**

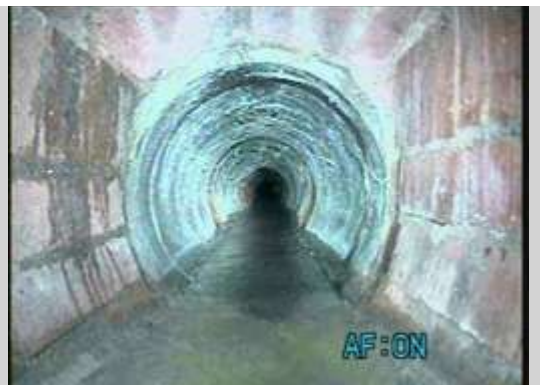
6 O'Clock Inflow

10 in. Circular Gravity Sewer
Pipe In @ 6 O'Clock

Pipe Material: **Clay** ☐ Pipe Lined

Invert Depth: **9.90** (ft.) Flow Characteristics: **Fast**

Deposits: ☒ None ☐ Mud ☐ Sludge ☐ Debris ☐ Grease

Infiltration: **None** Pipe Seal Cond: **Unknown**
